AGATA detector tests

University of Cologne
Herbert Hess

Experimental setup and specifications

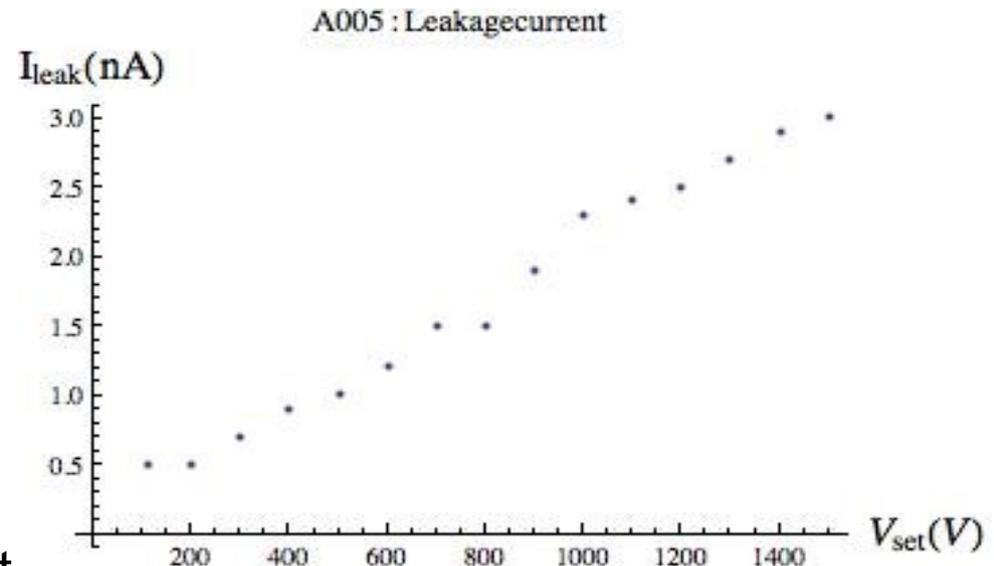
Test results A005 – 73949

Core: noise band did not decrease below 100mV (1500V)
leakage current increased linearly with applied HV
FWHM at 1.3 MeV: 13.07 keV at 6 μ s shaping time
11.23 keV at 3 μ s

Segments: noise band ~ 15mV
exception B6 ~ 80mV
FWHM at 1.3 MeV: B6 = 13.39keV
B3 = 2.27keV
B5 = 2.24keV
A6 = 2.03keV

-> Detector is suffering from leakage current
Confirmation of the Saclay results

-> Rejected

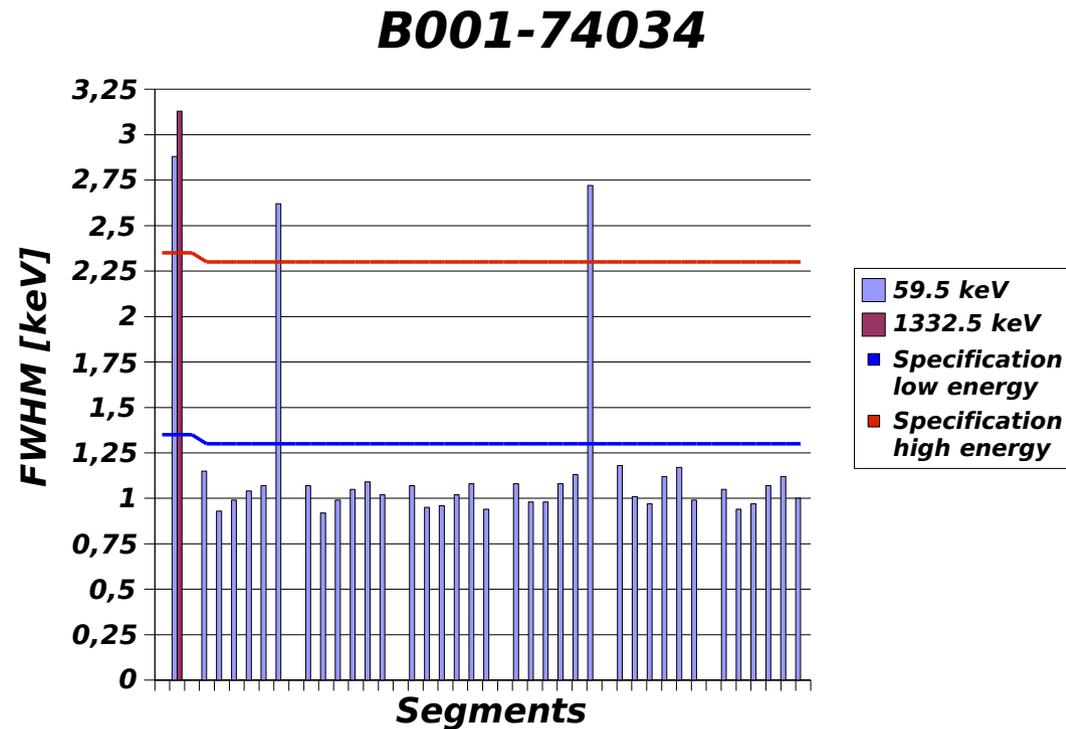
Test results B001 - 74034

Core FWHM at 1.3MeV : 3.26keV (6 μ s)
2.70keV (3 μ s)

Segments FWHM at 1.3MeV:

A6 = 2.62keV (6 μ s)

A6 = 1.49keV (3 μ s)

D6 = 2.72keV (6 μ s)

D6 = 1.86keV (3 μ s)

-> Detector suffers from leakage current over segments A6 and D6

-> Rejected

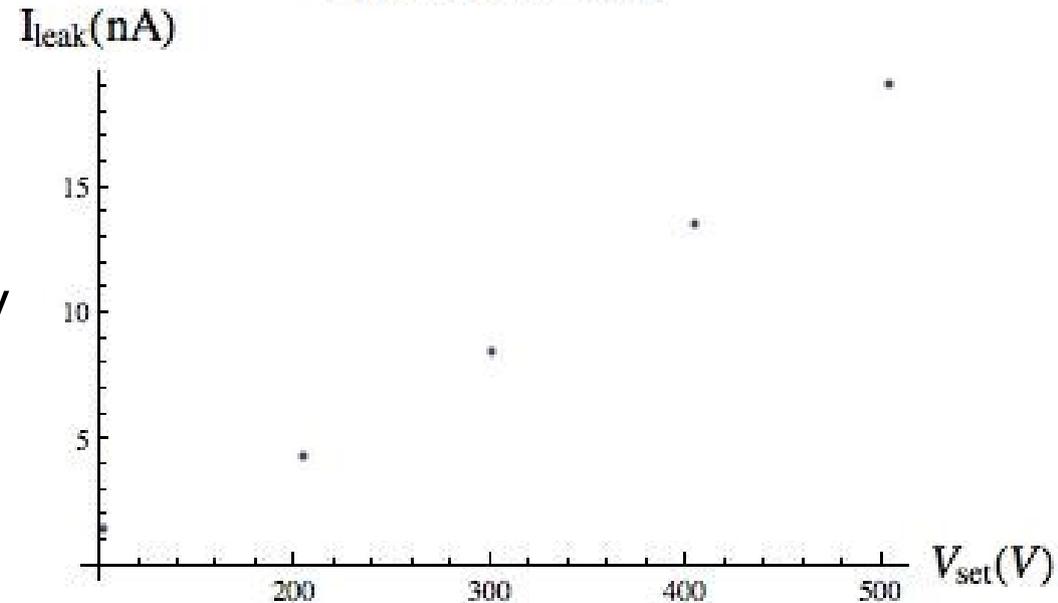
B005 : Leakagecurrent

noise band increases from 150mV at 100V to 500mV at 500V
at 3 μ s shaping time noise band 300mV
very high leakage current, 20nA at 500V

noise band 15mV at 500V
exception F6 ~ 200mV (200V)

-> detector not operational – confirmation of the Saclay results

-> Rejected

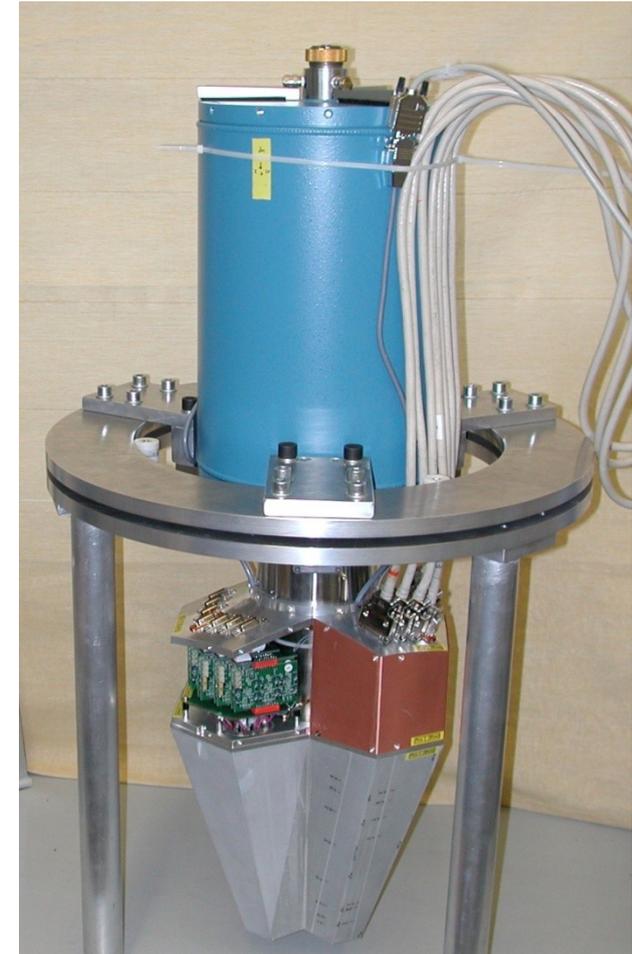
Test results B005 - 74065

Second delivery 05.03.09
in warm condition segment B6 missing

in cold condition all segments present

Core FWHM at 60keV 1.88keV (6 μ s)
1.89keV (3 μ s)

Segments FWHM F1 at 60keV > 4keV

-> out of specification

upside down position

FWHM at 60keV: core 1.30keV
F1 1.15keV

-> within specification

-> Test ongoing

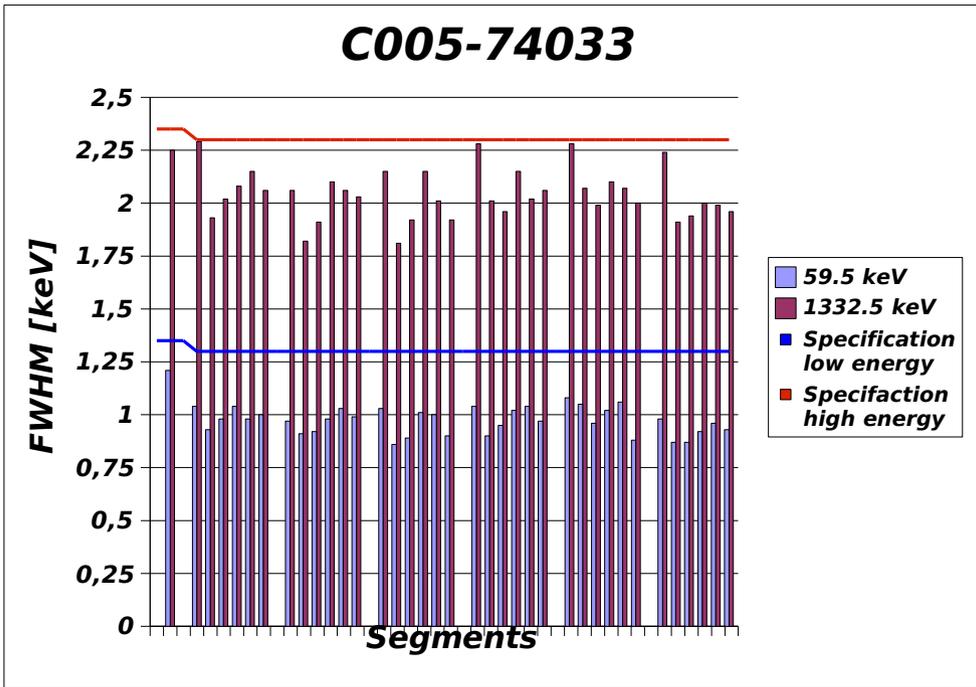
Test results C005 - 74033

Cross talk level is within specification of 0.1%

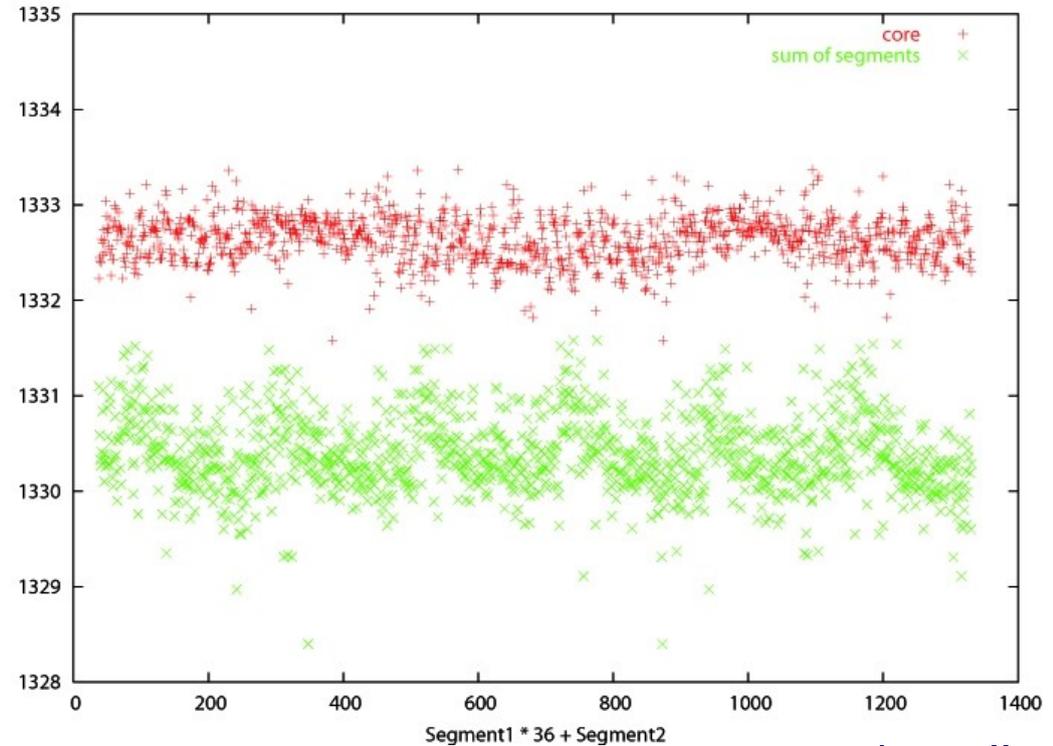
FWHM core at 122keV = 1.21keV
at 1.3MeV = 2.25keV

-> Mounted in ATC2

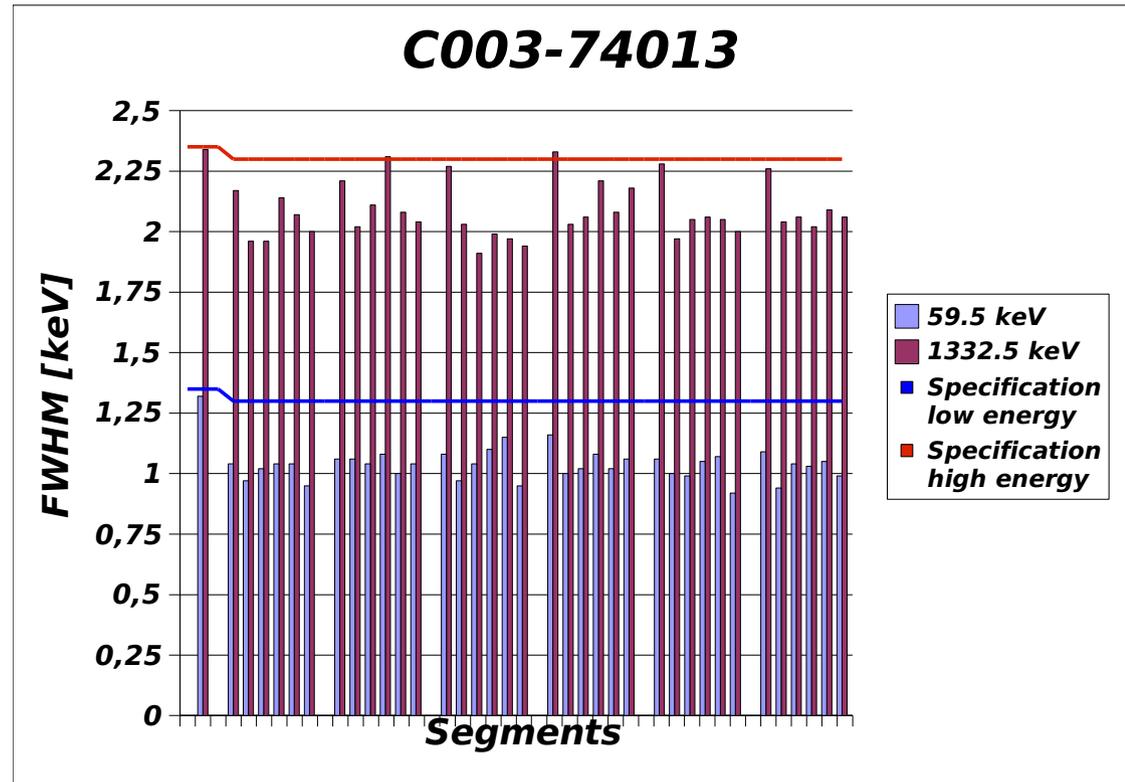
Status C003 - 74013

->leakage current over segment **C1**

FWHM core at 60keV = 1.32keV

1.3MeV = 2.32keV

-> leakage current over segment **C1**

FWHM segment C1 = 1.63keV (1.08keV in Testcryostat)

-> New detector test required
