Status of AGATA detectors

- deliveries
- customer acceptance tests
- neutron damage
- maintenance, annealing, ...

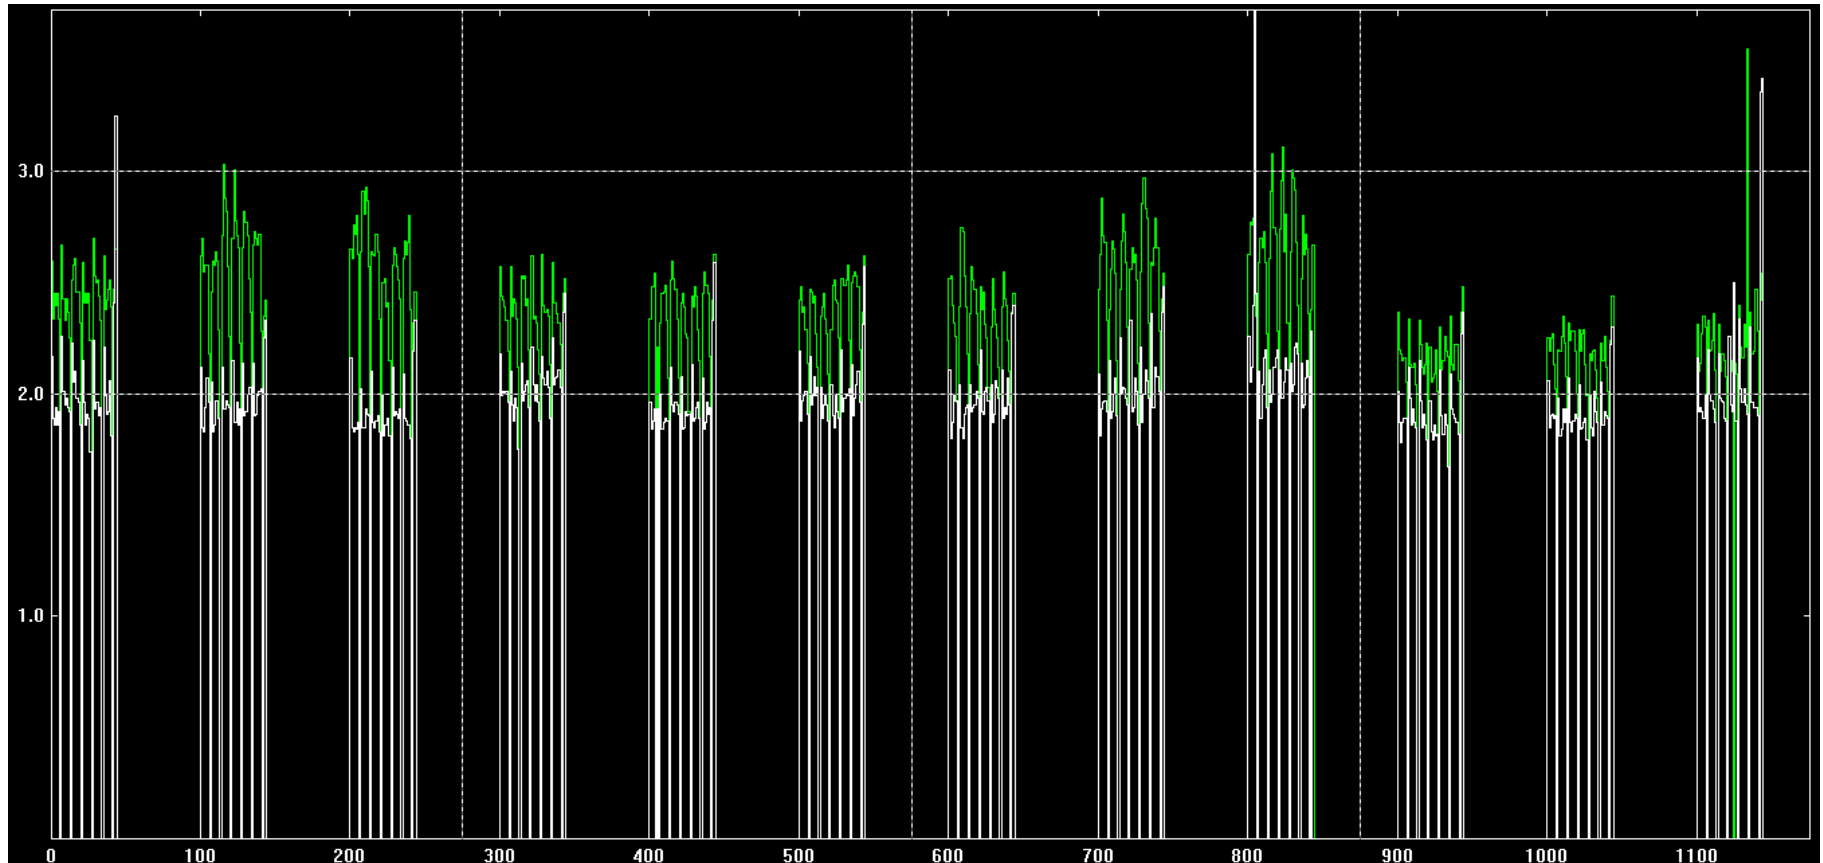
Neutron damage of AGATA clusters

Segment energy resolution values of ATC1 – ATC4

White: April 2010

Green: July 2010, after 3 high-rate experiments (3 weeks of beam at 30-80 kHz singles)

Worsening more severe on the forward crystals

Segments are the most affected, cores almost unchanged

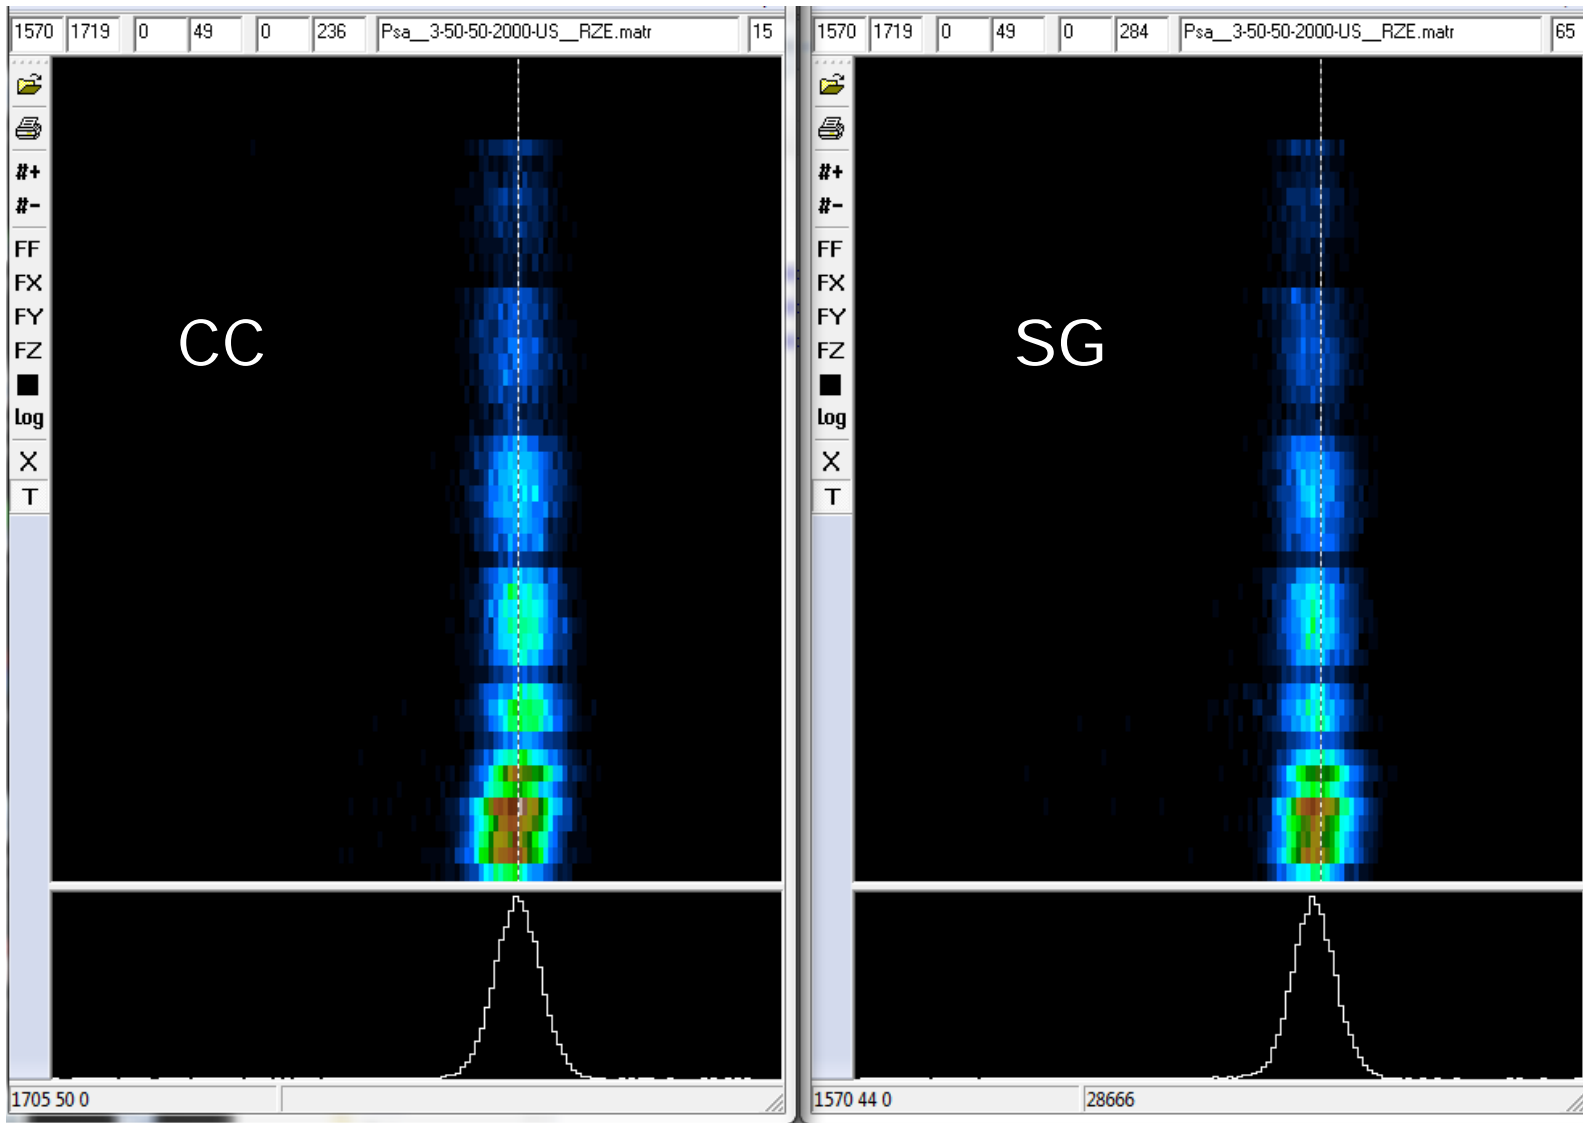
1B April 2010

The 1332 keV peak as a function of crystal depth (z) for interactions at r=15mm

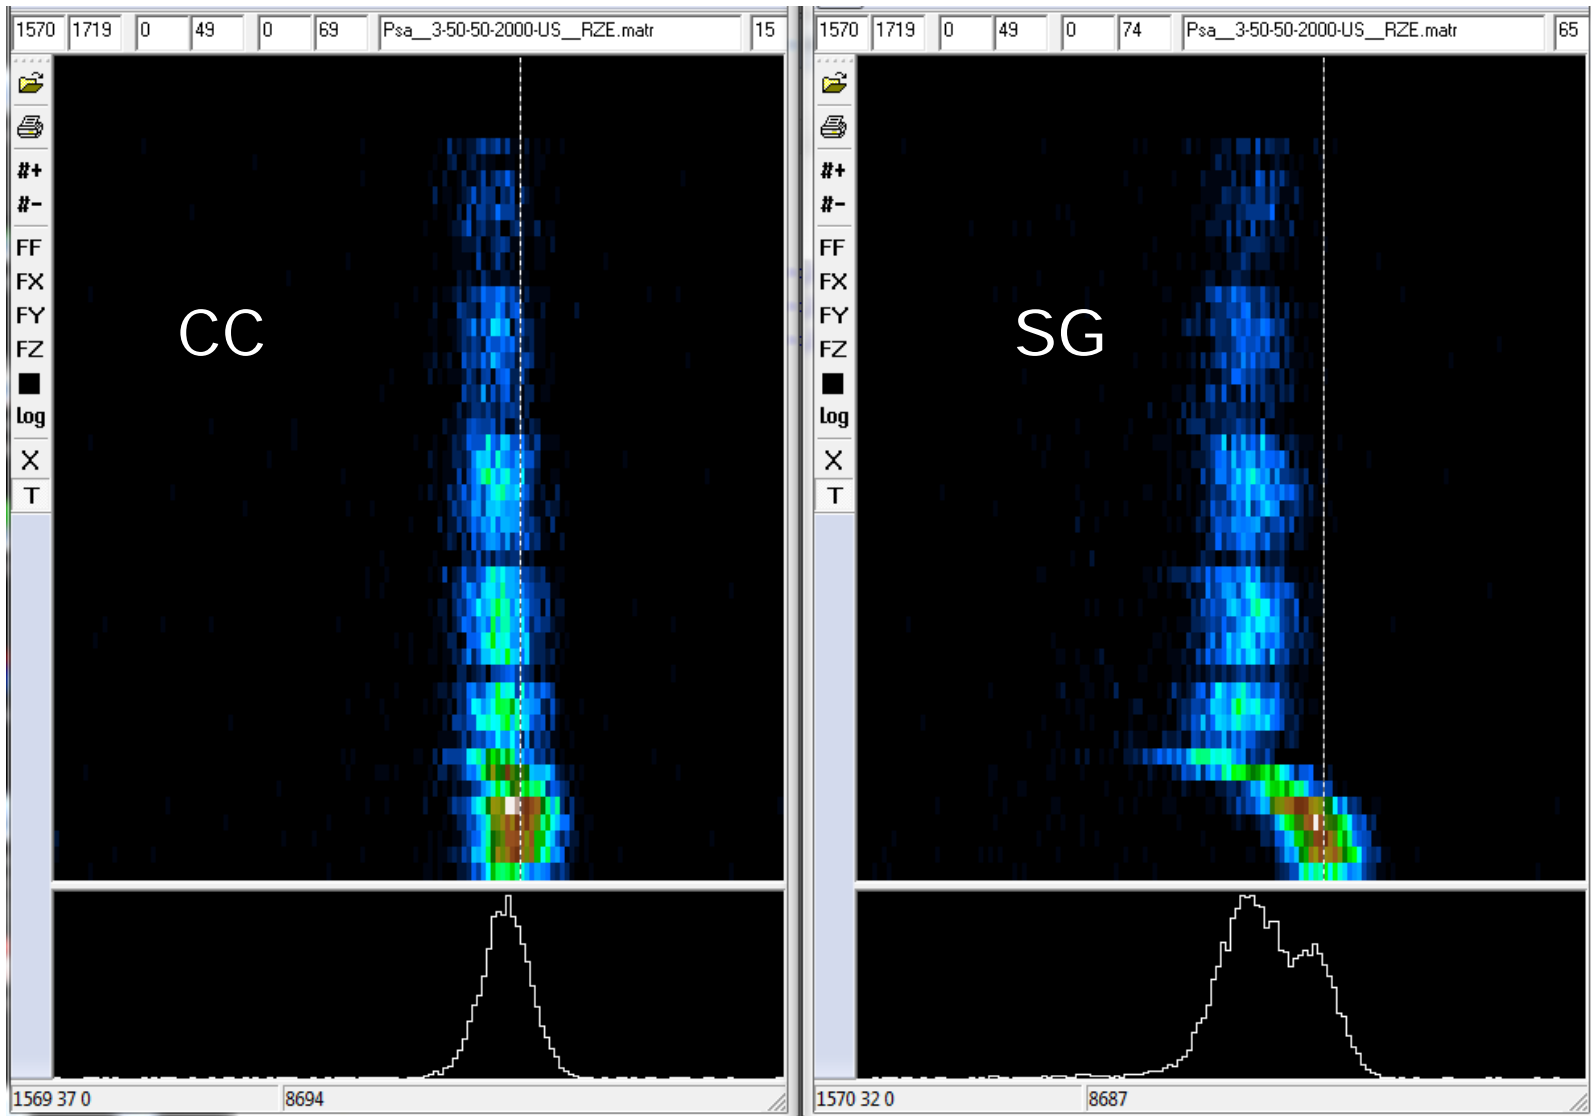
1B July 2010

The 1332 keV peak as a function of crystal depth (z) for interactions at r=15mm
Position of the hits derived from the GRID search PSA

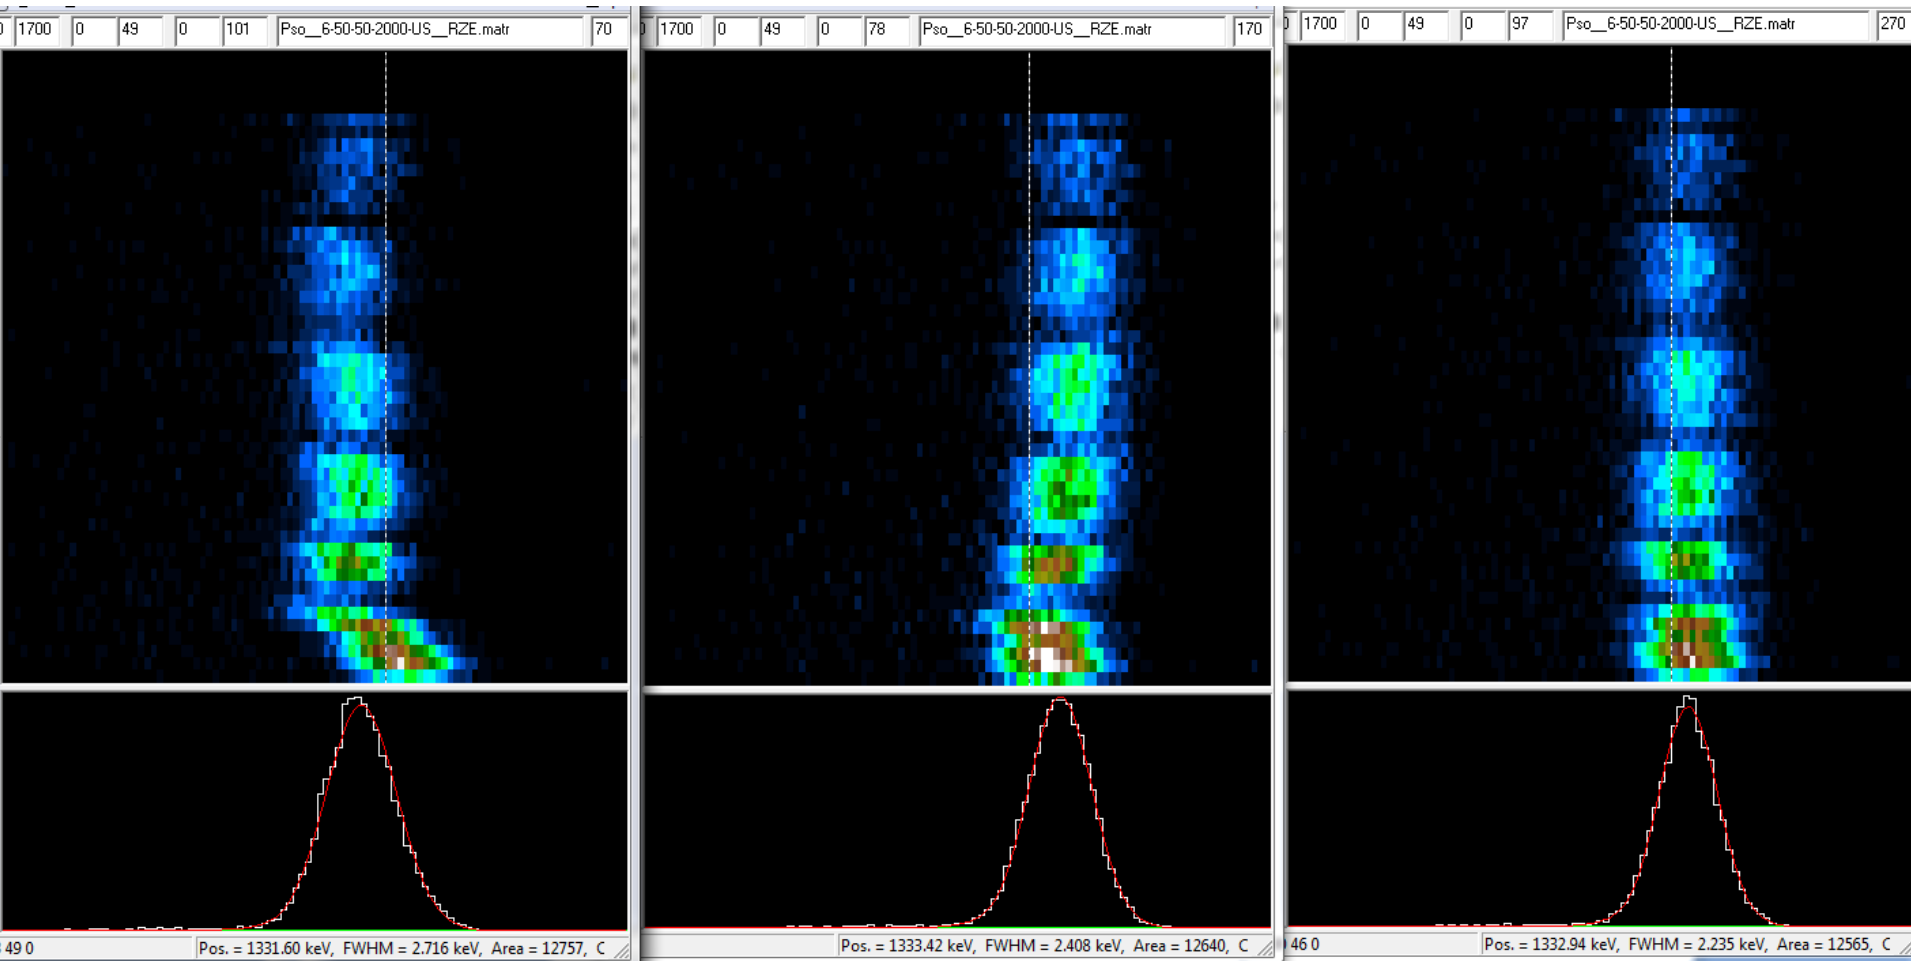
Segments, 1B(C002), r=20 mm

Position dependent neutron damage correction works!

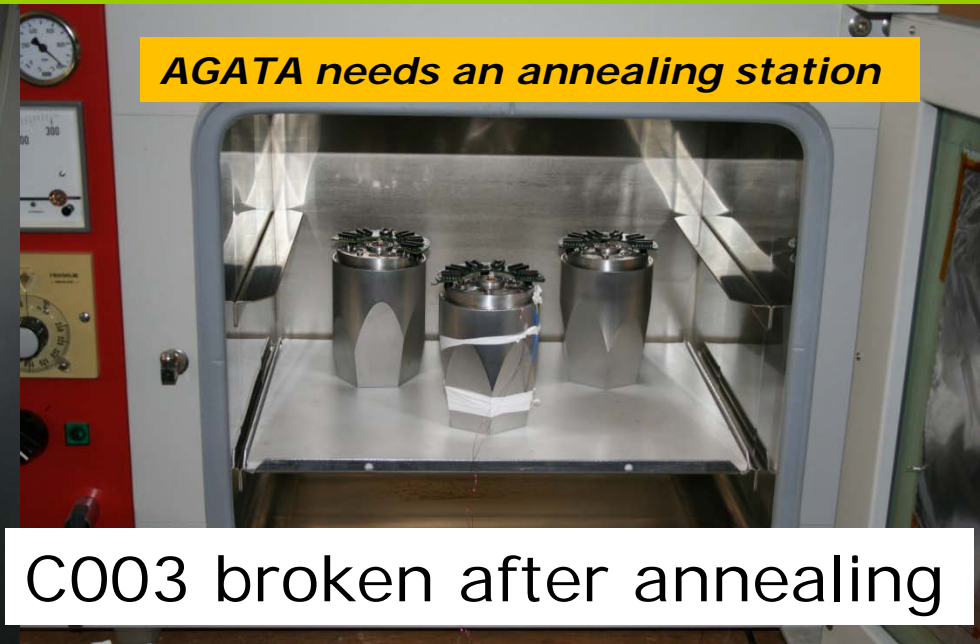
C003 broken after annealing

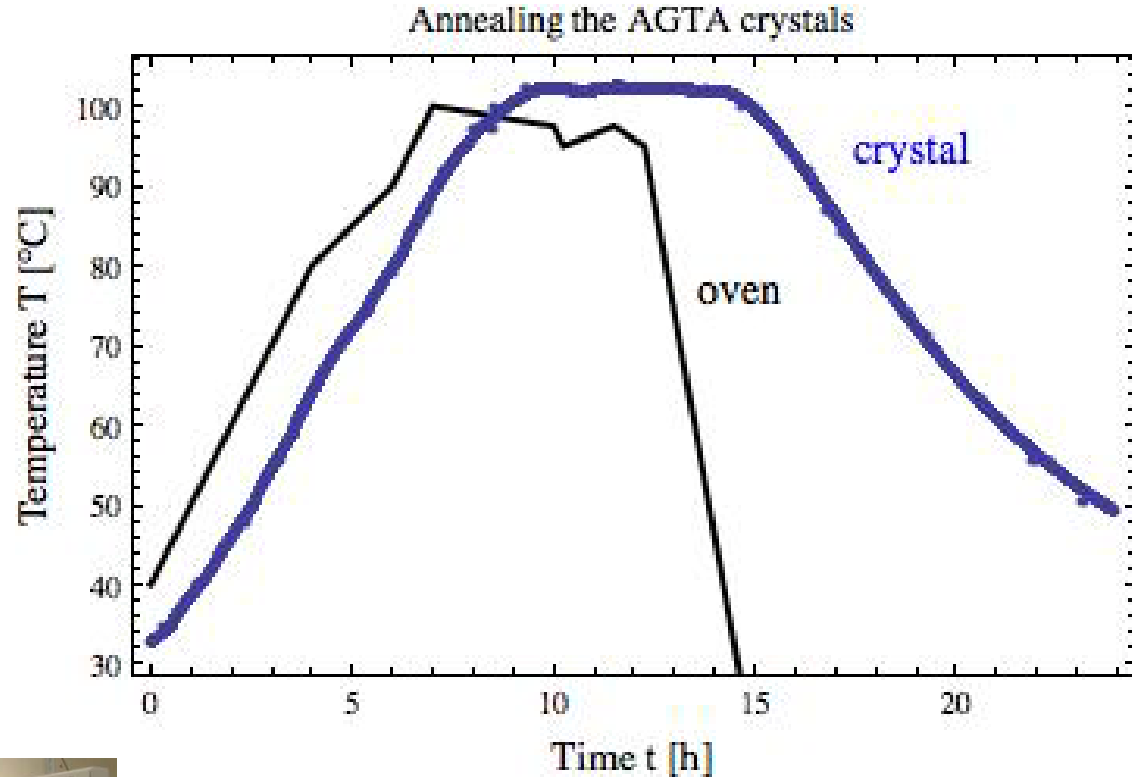
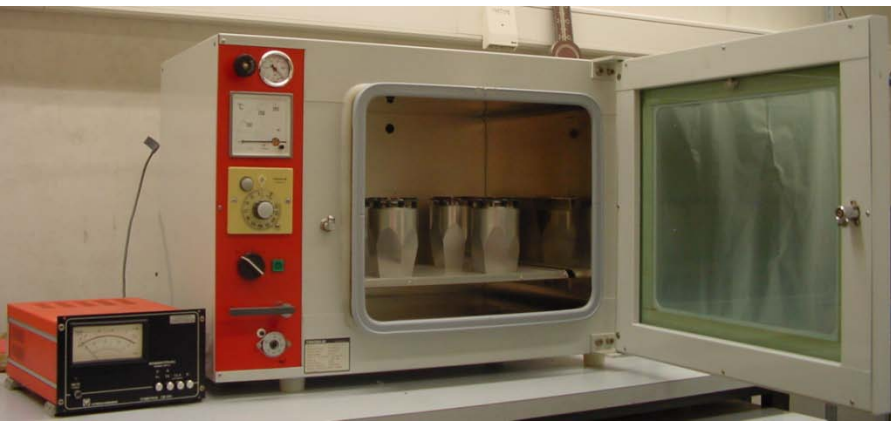
1. Annealing of crystals

- Annealing of crystals
A001, B002, C002, B001
- Increased annealing
time: 5h @ 102°C

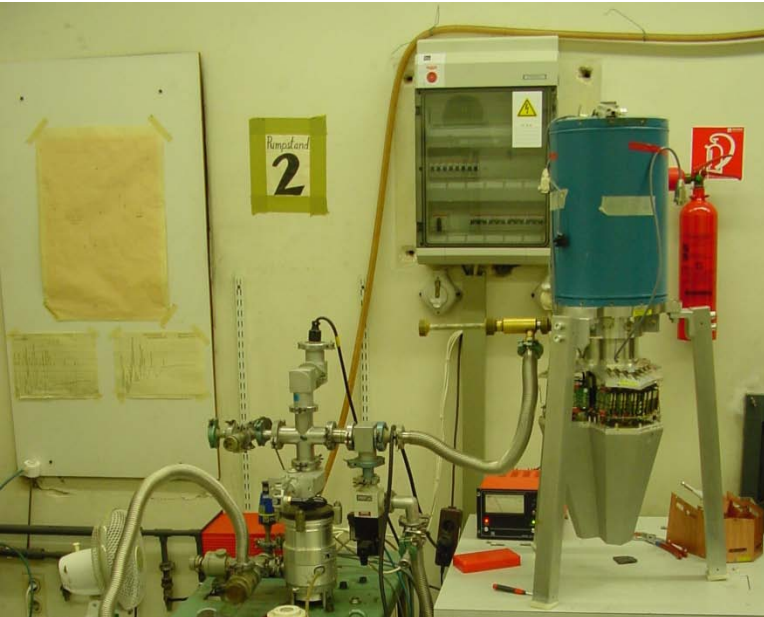
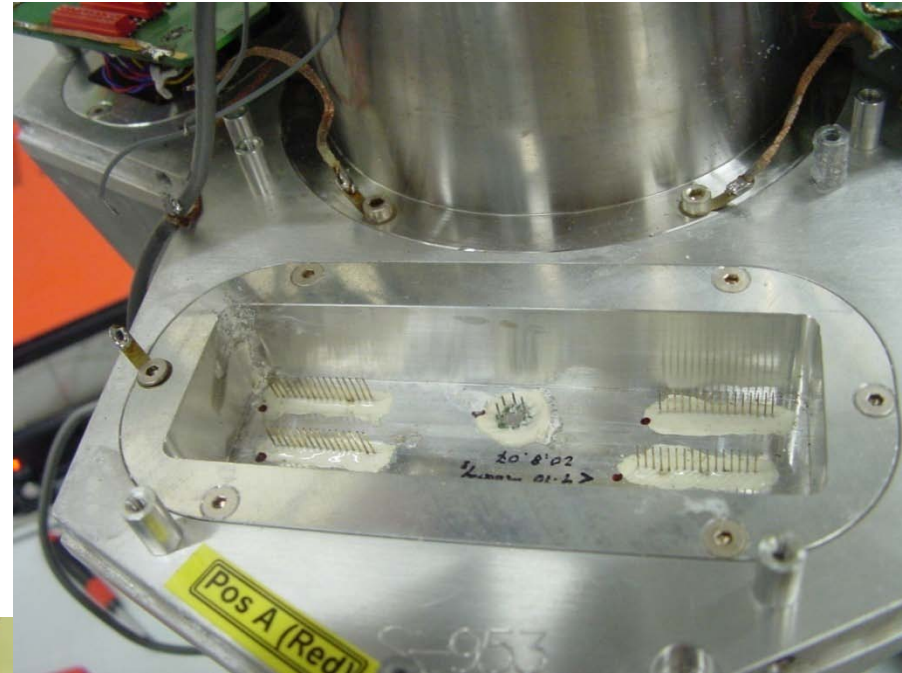
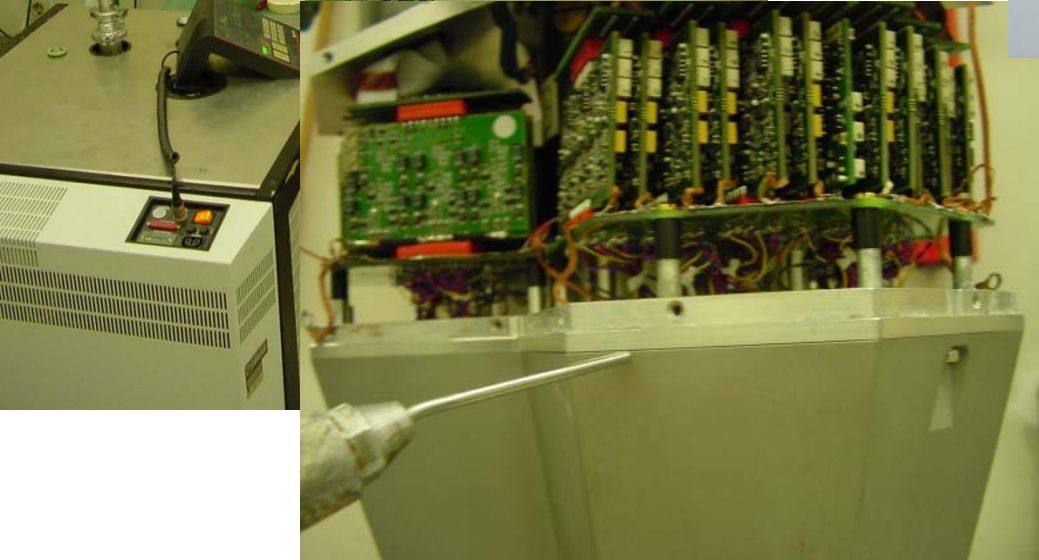
3. Leak-Test of ATC-Cryostats

ATC(4): vacuum o.k.

ATC(1): broken vacuum feed throughs
⇒ replacement, new flanges

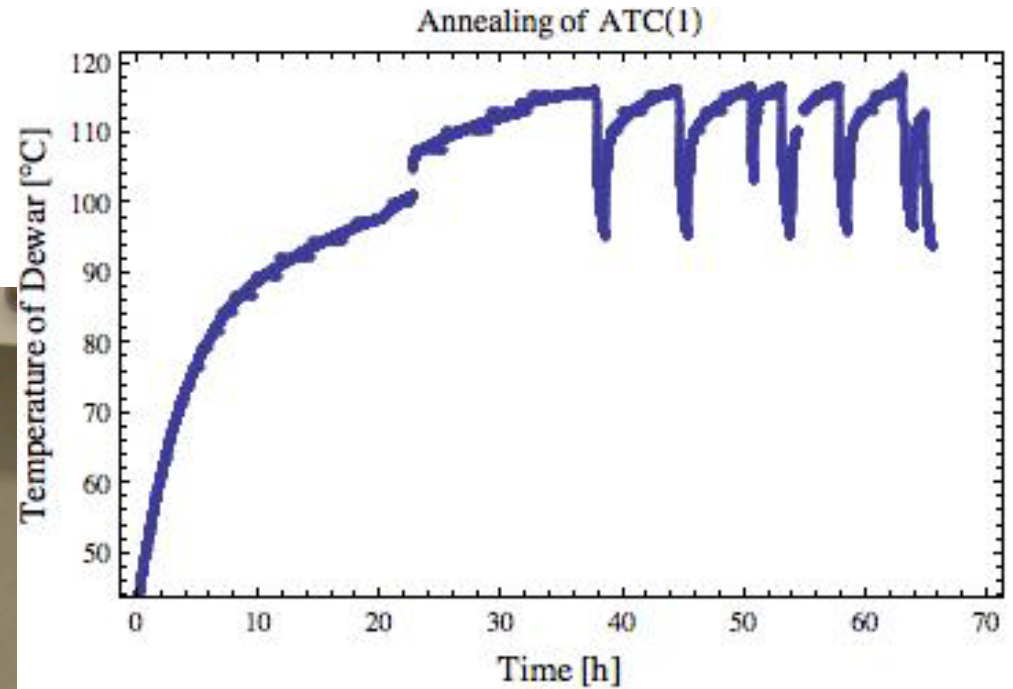
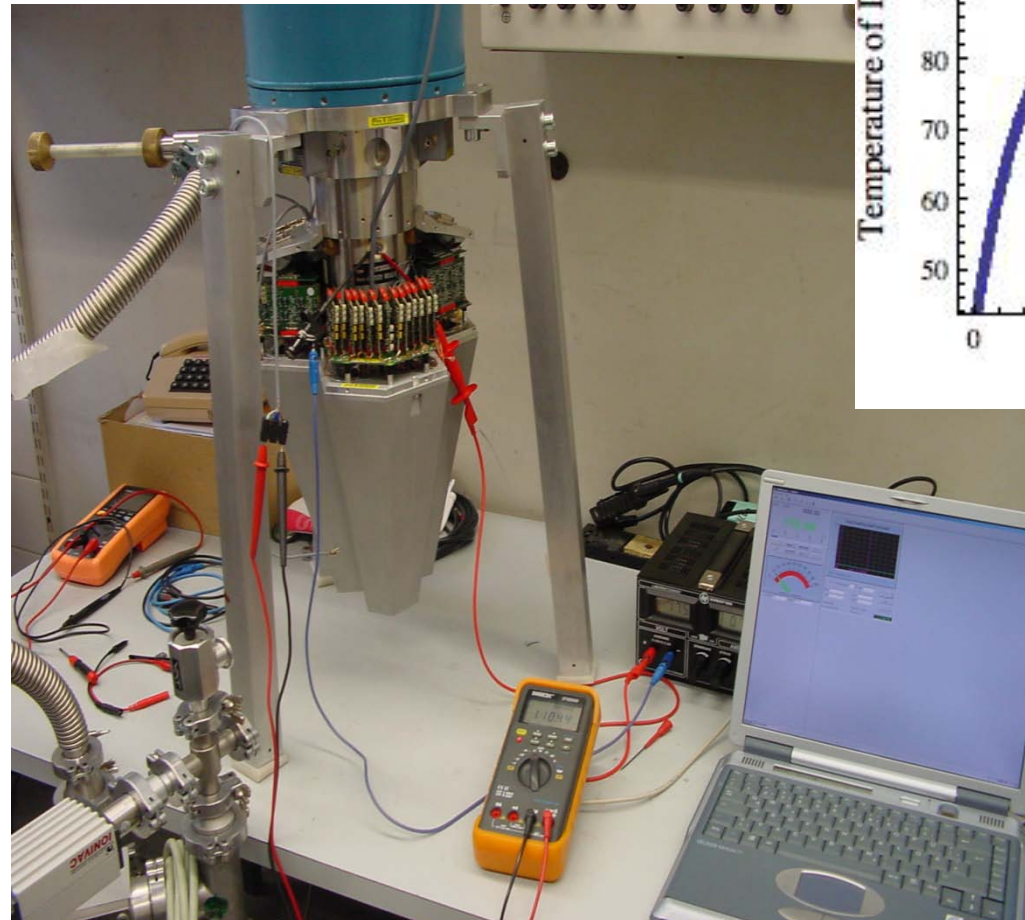
4. Annealing of ATC-cryostats

- heat power $\sim 20\text{W}$
- Max. temp. $\sim 110^\circ\text{C}$ for several days

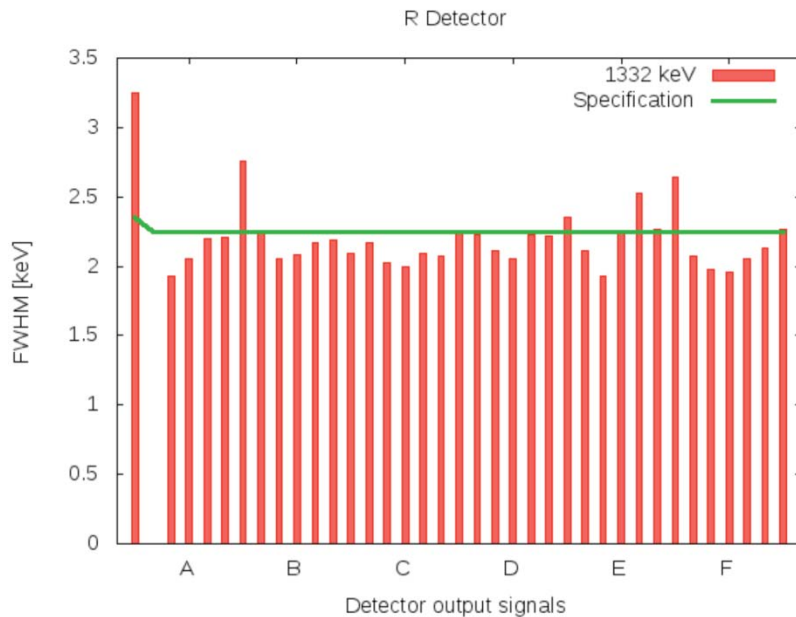
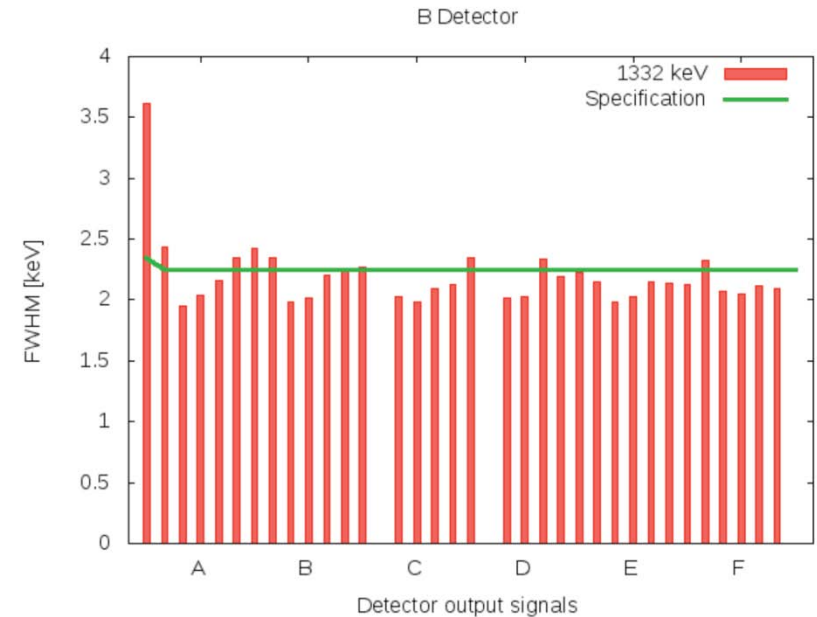
6. Final test of detectors

Example ATC5

-energy resolution at 1.3 MeV of detector A and C

All segment signals of ATC1, ATC4, ATC5 o.k.

Some cores need improvement
